NATIONAL DAM INSPECTION PROGRAM. TILLSON LAKE DAM (NY 00083), L--ETC(U)

REPORT DOCUMENTATION PAGE		READ INSTRUCTIONS BEFORE COMPLETING FORM
1. REPORT NUMBER	2. GOVT ACCESSION NO.	3. RECIPIENT'S CATALOG NUMBER
AD A105851		
4. TITLE (and Subtitle) Phase I Inspection Report Tillson Lake Dam Lower Hudson River Basin, Ulster County, N.Y. Inventory No. 83		5. TYPE OF REPORT & PERIOD COVERED Phase I Inspection Report National Dam Safety Program

National Dam Inspection Program,
Tillson Lake Dam (NY 00083), Lower
Hudson River Basin, Town of Gardiner,
Ulster County, New York. Phase I
Inspection Report.

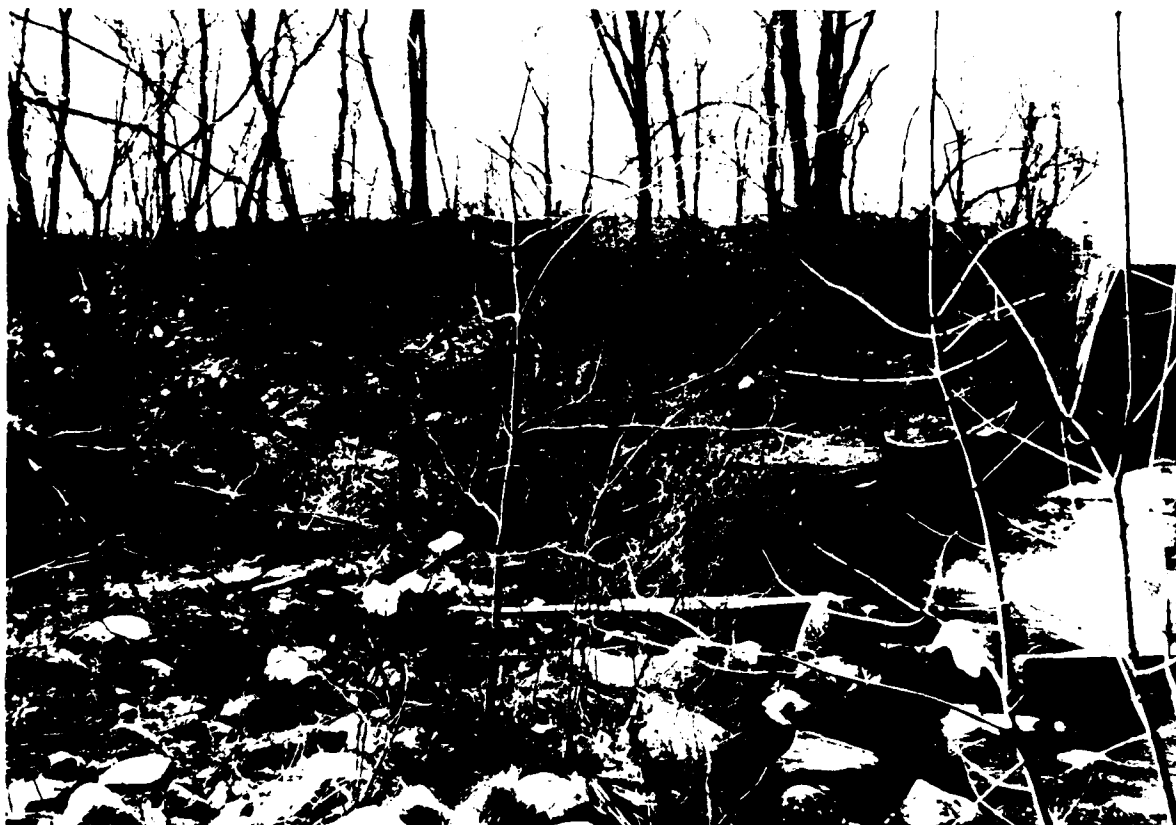
Overview Photo - Tillson Lake Dam. Note trees on slope and irregular crest - 4/8/81

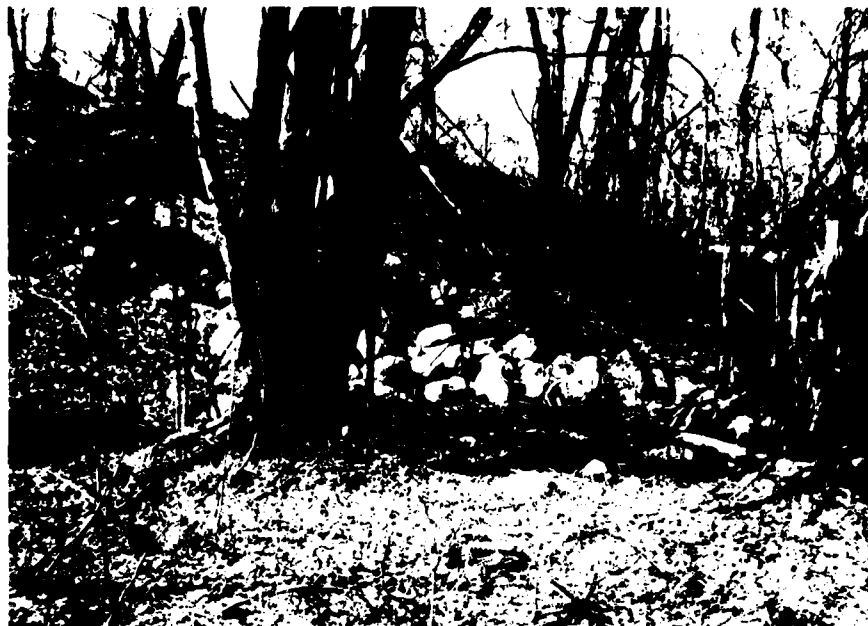
A-3A Downstream slope of dam from 20 feet downstream of toe
at about Sta 3 + 00 - 4/8/81

- 1) Investigate the character of the spoil material on the downstream slope to determine whether it should be removed and, if so, provide the procedure for removal.
- 2) Determine whether major repairs should be made to the core wall, which has multiple cracks.
- 3) Investigate the origin of the seeps through the floor of the spillway discharge channel.

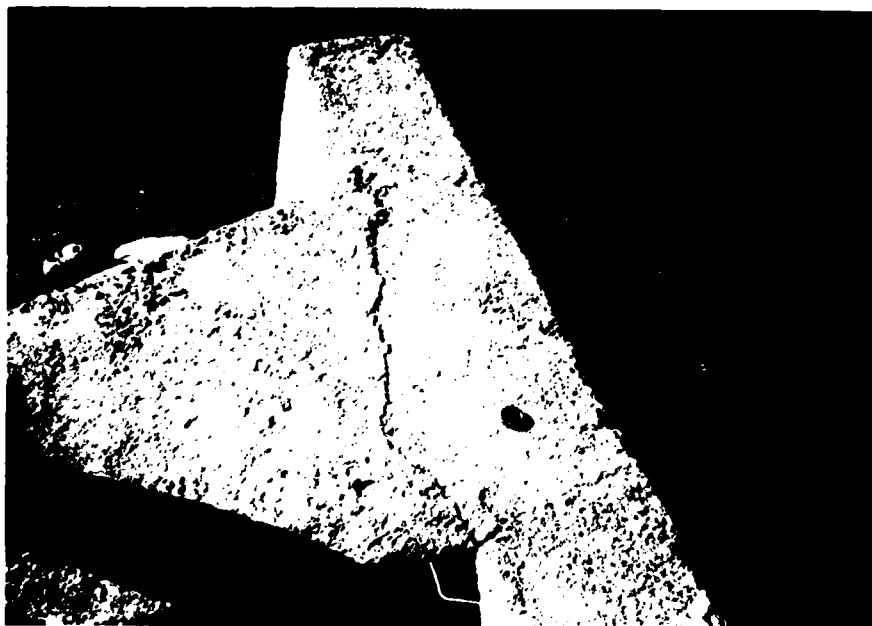
A-3B Crack at core wall and right training wall junction - 4/8/81

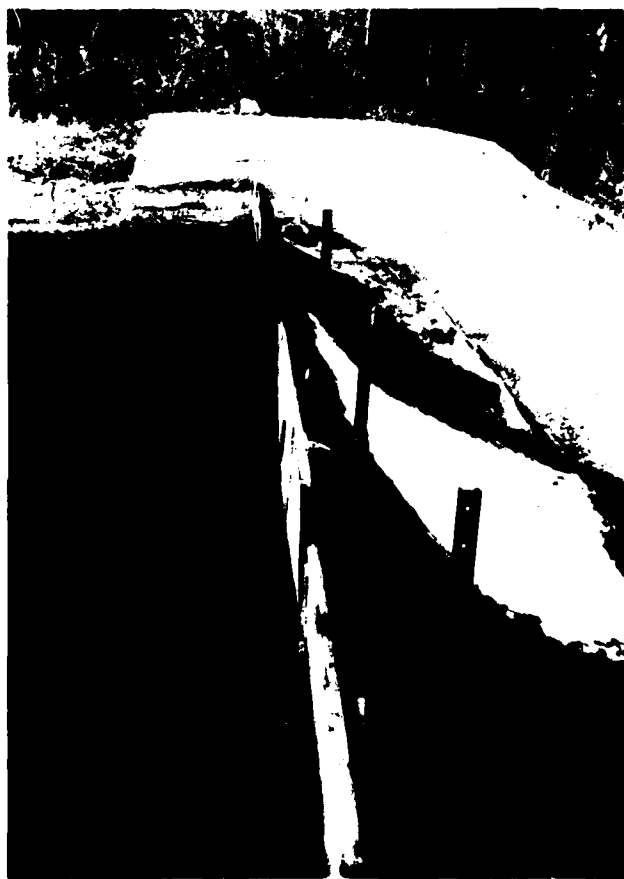
A-6B Spillway crest looking toward left abutment. Note erosion at ogee and channel transition and siltation upstream of weir - 4/8/81

- 6) Contingent on the results of the detailed stability analysis by an engineer, repair the zones of eroded and deteriorated concrete of the spillway, discharge channel, and training walls in accordance with a design by an engineer.

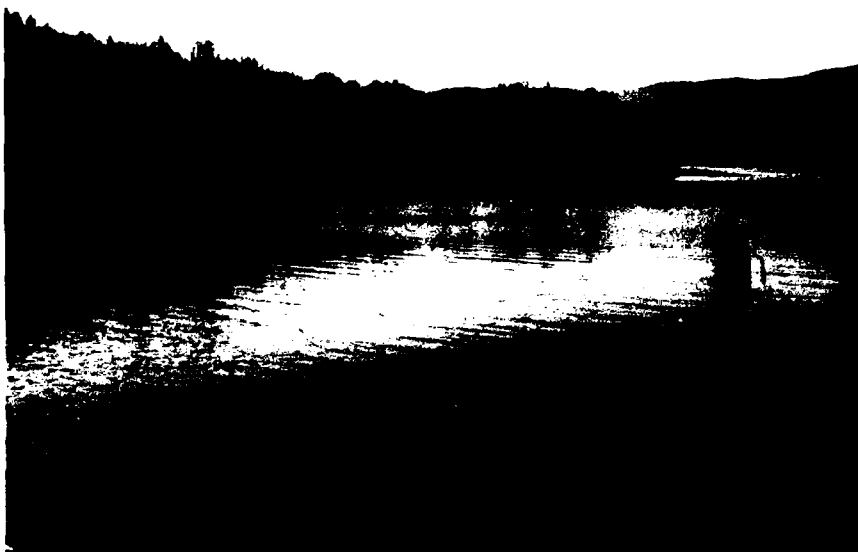
A-9A Reservoir shoreline looking upstream from dam. Note control tower at left - 4/8/81

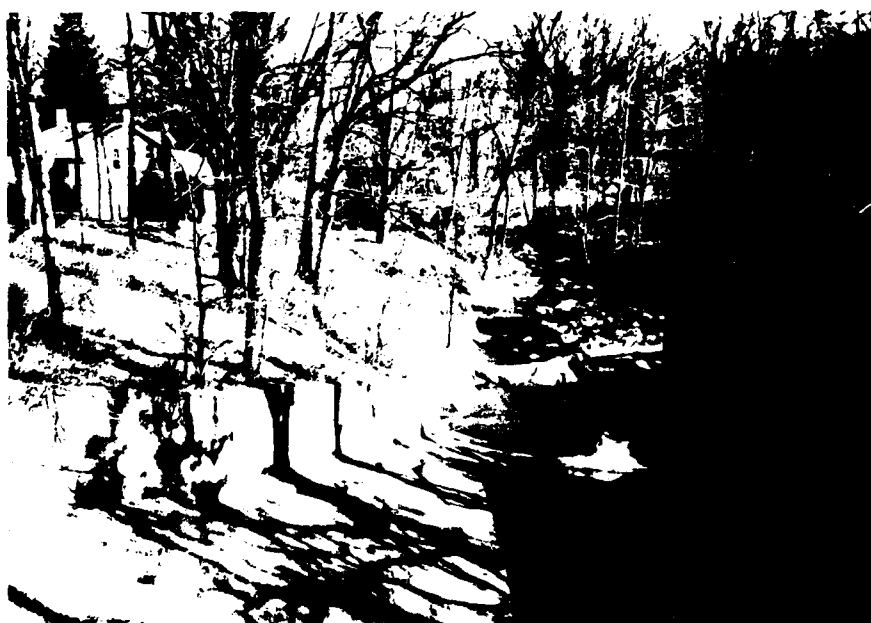
A-9B Downstream channel from spillway crest - 4/8/81
